Maryland Inventory of Historic Properties number: SM-507

Name: MD 242 (COLTON R. RD) OVER ST. CLEMENTS CREEK

SHA Bridge No. 18020 Bridge name MD 242 (Colton Point Road) over St. Clements Creek

**INDIVIDUAL PROPERTY/DISTRICT
MARYLAND HISTORICAL TRUST
INTERNAL NR-ELIGIBILITY REVIEW FORM**

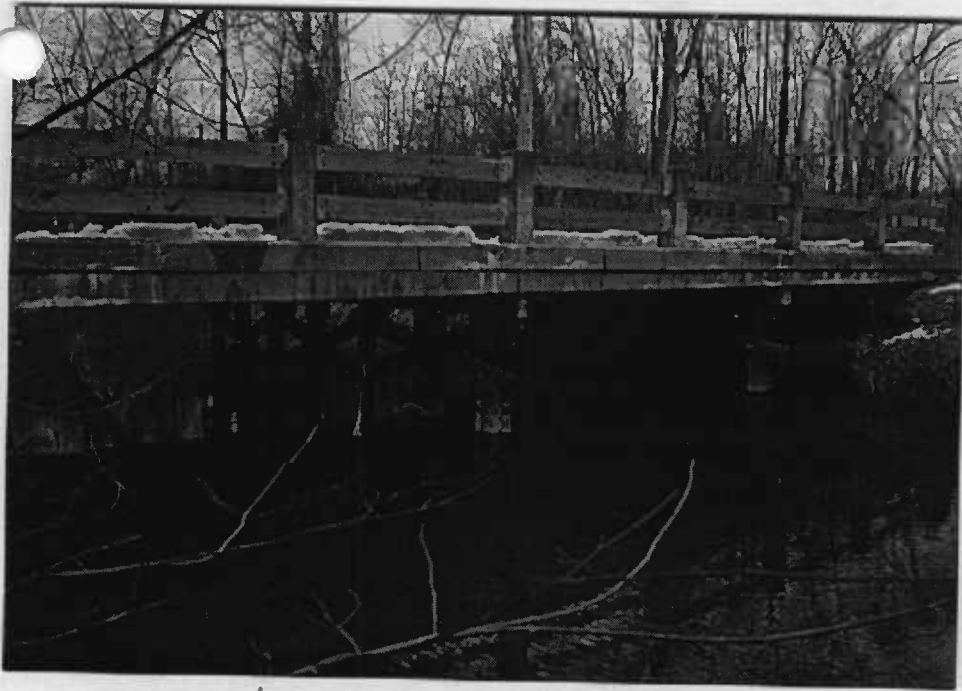
East End

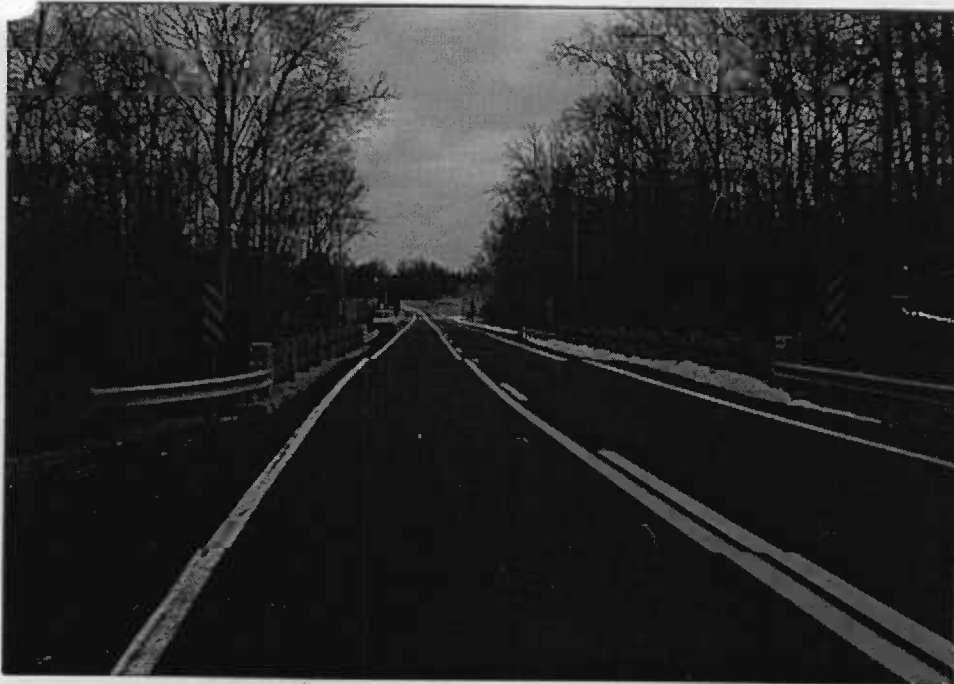
Looking North
